CHURCH OF THE HOLY SEPULCHRE JERUSALEM

STRUCTURAL SURVEY
FINAL REPORT

BY
WILLIAM HARVEY

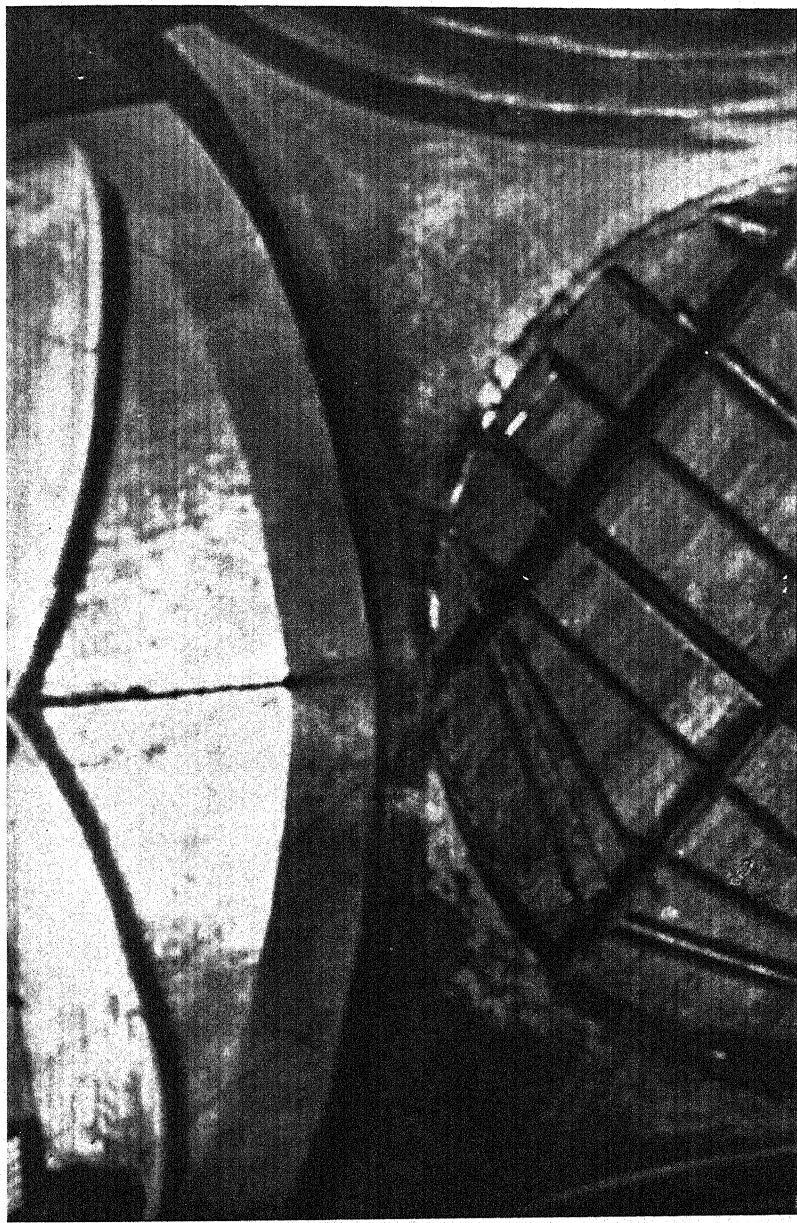
FIG. 1. EASTERN PENDENTIVES FROM BENEATH

The thrust is first communicated in a direction both downward and outward to the pendentives (see Figs. 1, 2, II, 24) supported on the four great arches of the crossing. It is to the position of the dome above the pendentives that the outward thrusts must be ascribed (see Fig. II).

The pendentives (see Figs. 1, 2, II, 24) receive the weight of the dome and transmit it to the four main piers below, but there is also considerable outward thrust, as the pendentives are not vertical, but inclined inwards to the bottom of the drum above. They were completely plastered over after the fire of 1808, and do not themselves show signs of great movement, except in the North-west pendentive, which is badly cracked. The piers below have decided leans outwards in the upper portions, and from this inclination the further parts of the building have received the damaging thrusts (see Additional Notes, p. 14).

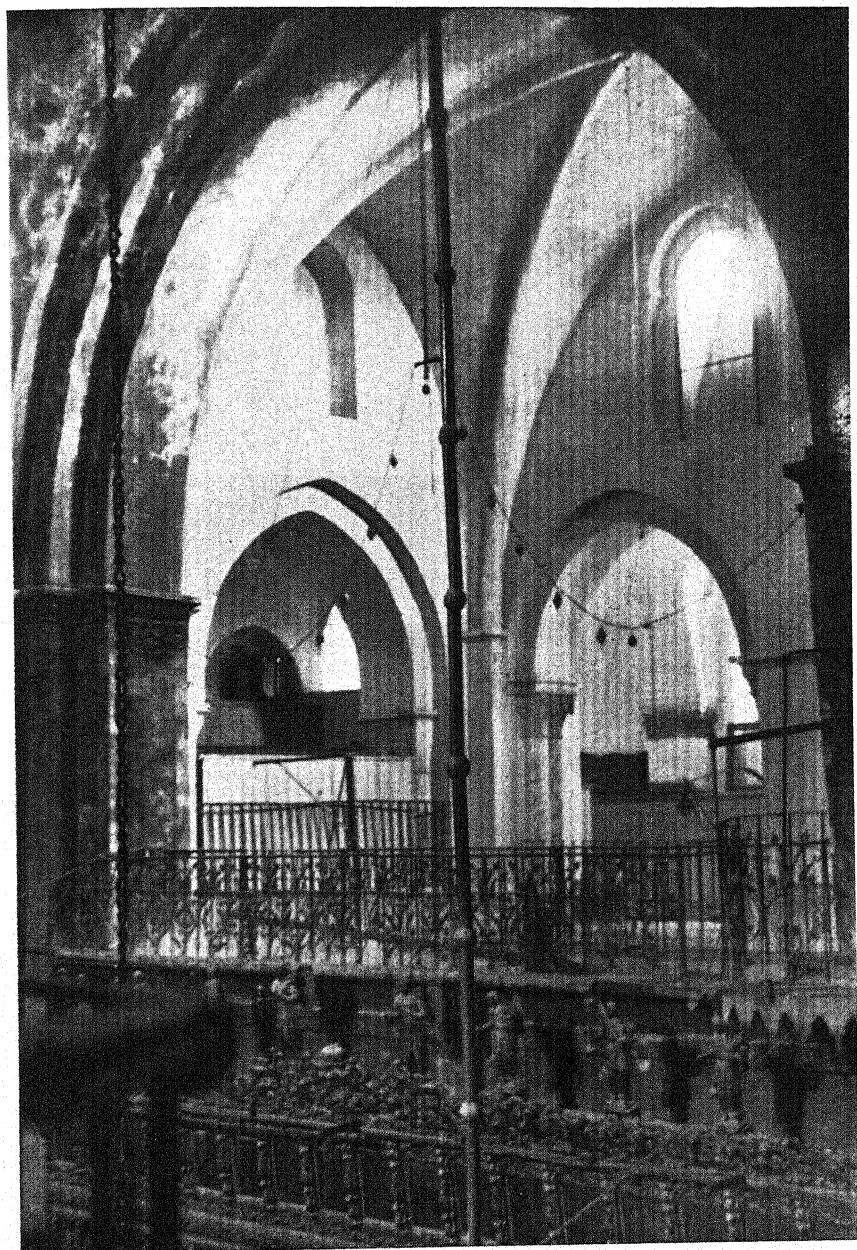
FIG. 3. NORTH TRANSEPT HIGH VAULT FROM S.E.

The North Transept proper consists of only one bay, with a vault above the main springing level of the great arches, and consequently occupying the same vertical space as the pendentives of the dome (see Figs. 3, I, 3). To the north of this bay is a gallery with two floors (see Fig. II, 9)—both originally of Byzantine construction; the lower vault (see Fig. 4) being below the Triforium arcades of the Transept proper. The upper vault (see Fig. 5) is above the Triforium, while leaving a clerestory lighting the high vault of the Transept above (see Fig. 6). This higher vault of the gallery is therefore in a position to receive

the full thrust of the springing of the high vault (see Fig. 3) which it communicates to the North wall of the gallery, here an exterior wall of the Church. This wall contains the most dangerous evidence of movement in the building (see Fig. IV). For the lower half of its height, its outward inclination is approximately 1 in 60, but above this, for three metres below the sills of a series of windows lighting the upper gallery, it becomes rapidly sharper, reaching 1 in 20 and even 1 in 16. This is the more serious in that this upper walling contains work of several periods, ill bonded together, and much of the mortar has disappeared (see Fig. 7).

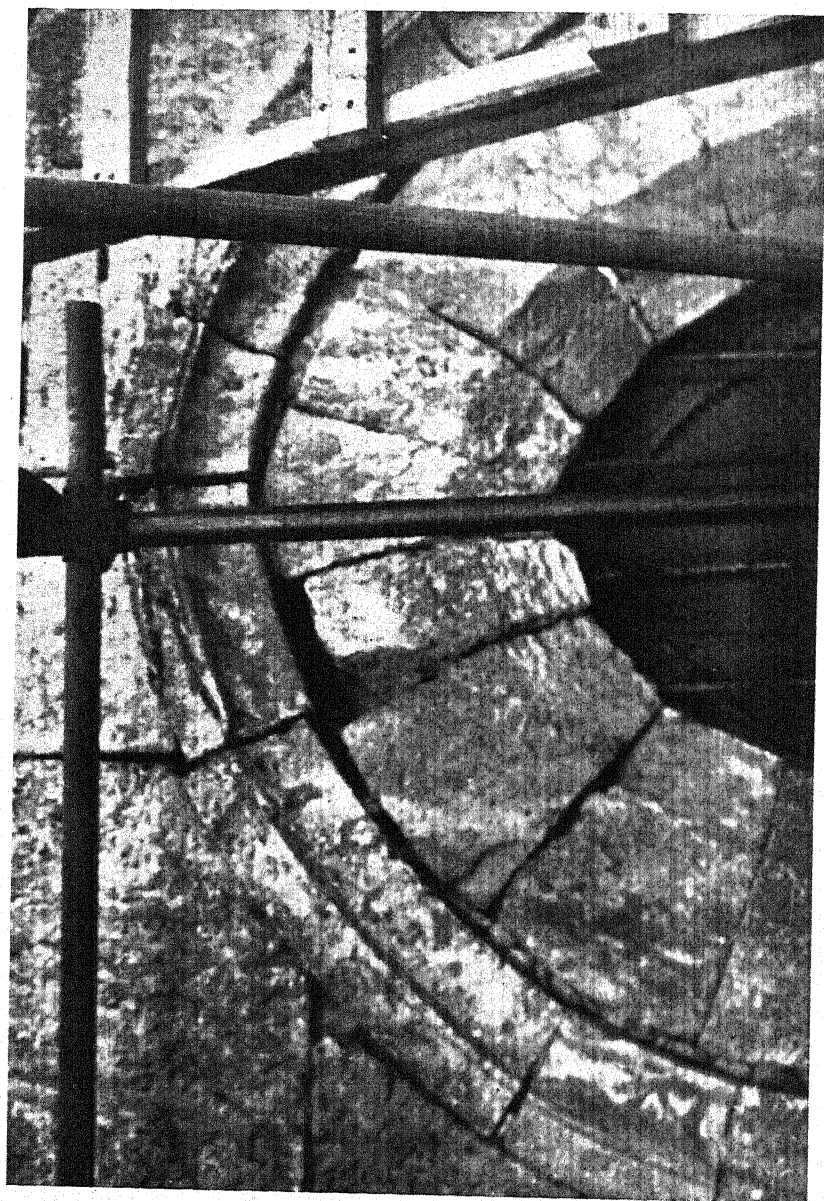
FIG. 8. A WINDOW-HEAD—NORTH WALL

Several instances occur of wide open joints penetrating through more than half the thickness of the wall, while the inner courses of voussoirs to the window arches have fallen downwards, leaving a wide space below the higher masonry (see Fig. 8). As the wall is restrained at each end by other buildings, leaving less than thirteen metres free to move outwards, such a grave inclination in the centre has resulted in great curvature of the wall-top (see Fig. 9) and this, together with the overhang and poor state of the mortar joints, may at any time allow the fall of some of the facing stones—should this occur any attempt to save the rest of the wall would be extremely dangerous, and collapse of the high vaults behind might easily follow.

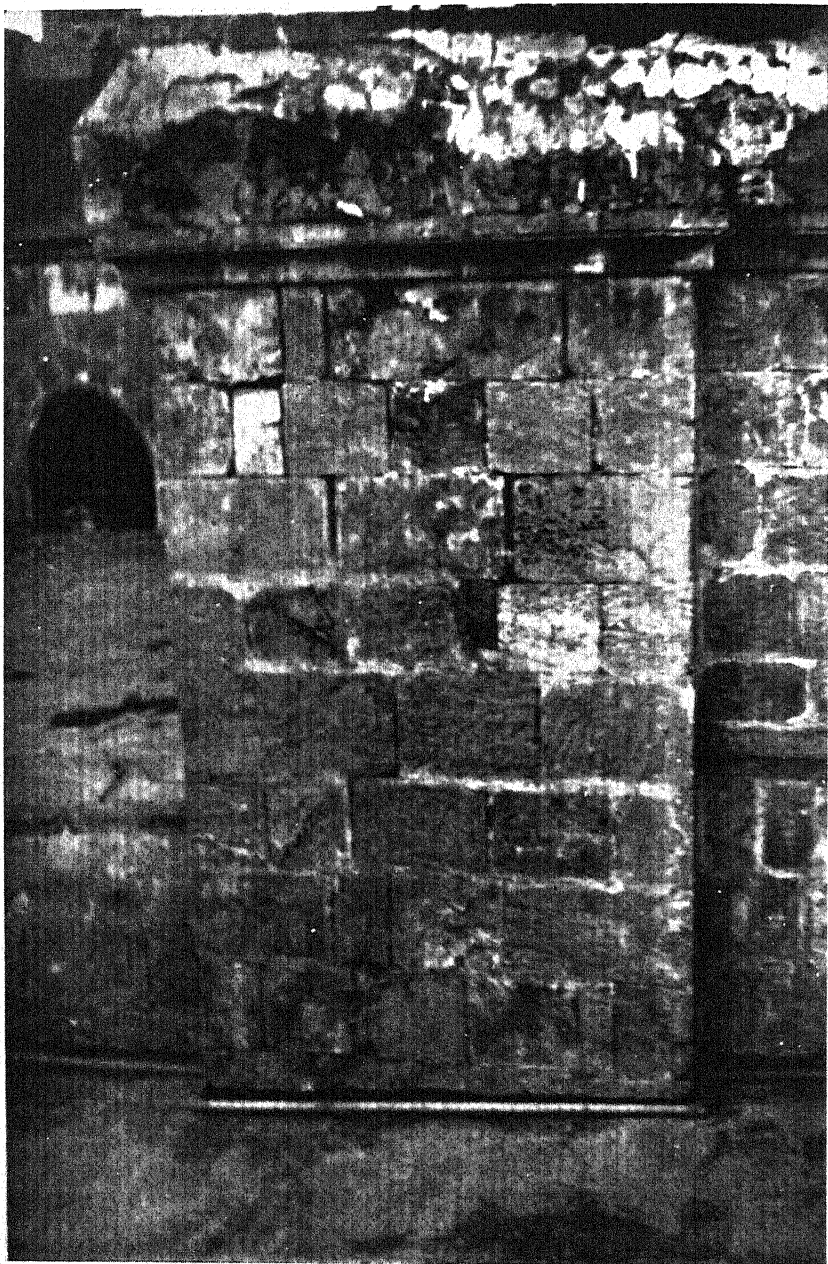
FIG. 12. N.E. CORNER OF NORTH TRANSEPT

The high vault itself (see Fig. 11) has also been plastered, but some two years ago a large stone fell from one of the main ribs, and the upper walls, where accessible from outside, are in an extremely poor condition (see Figs 12, 13, 14), many joints being completely denuded of mortar, and much of the masonry cracked and suffering from erosion, and to some extent from the effects of the fire of 1808.

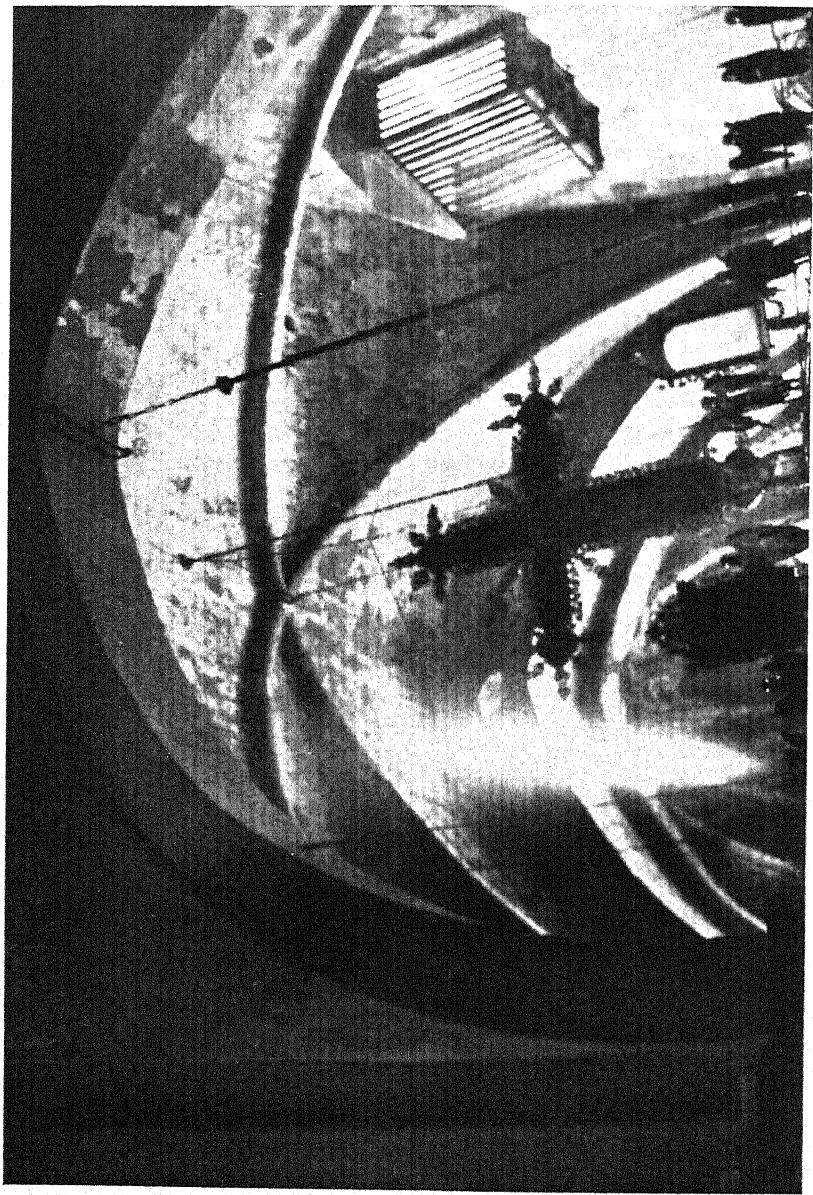
FIG. 16. EASTERN ARM HIGH VAULT FROM W.

The Eastern arm of the Church dates from the twelfth century, but the work is obscured by the plastering and additions of 1810 (see Figs. 16, 17, I, 5-II, 2). The apse (see Figs. I, 6-II, 3) is divided into two stories, of which the lower probably retains a twelfth-century core, while the upper is completely of the 1810 rebuilding. While the lower work remains upright, owing to the buttressing effect of many low vaults entirely surrounding it, the upper work is in a bad state of disrepair (see Fig. 18).

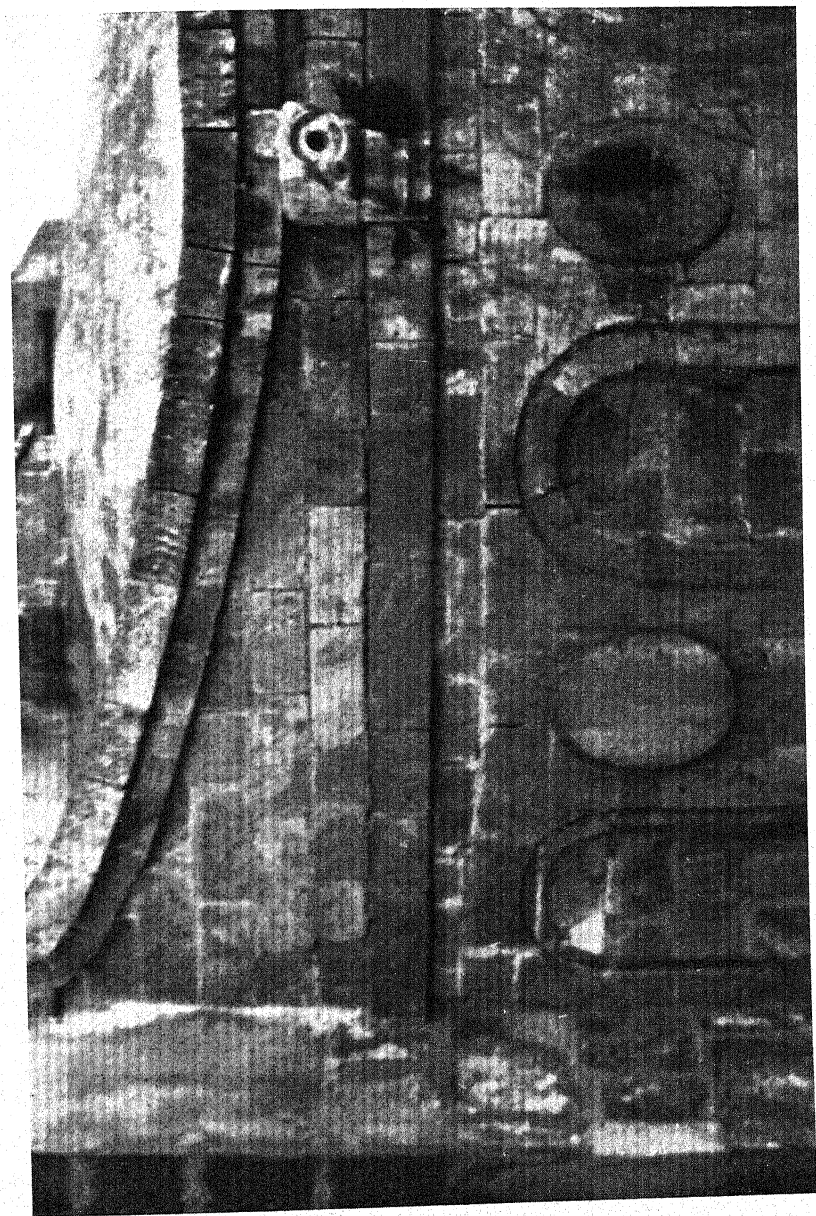
FIG. 19. APSE PARAPET

Near the apse roof, the bed-joints of several courses are devoid of mortar (see Fig. 19), and the parapet, unrestrained by any tie-bars, has moved outwards (see Fig. 20).

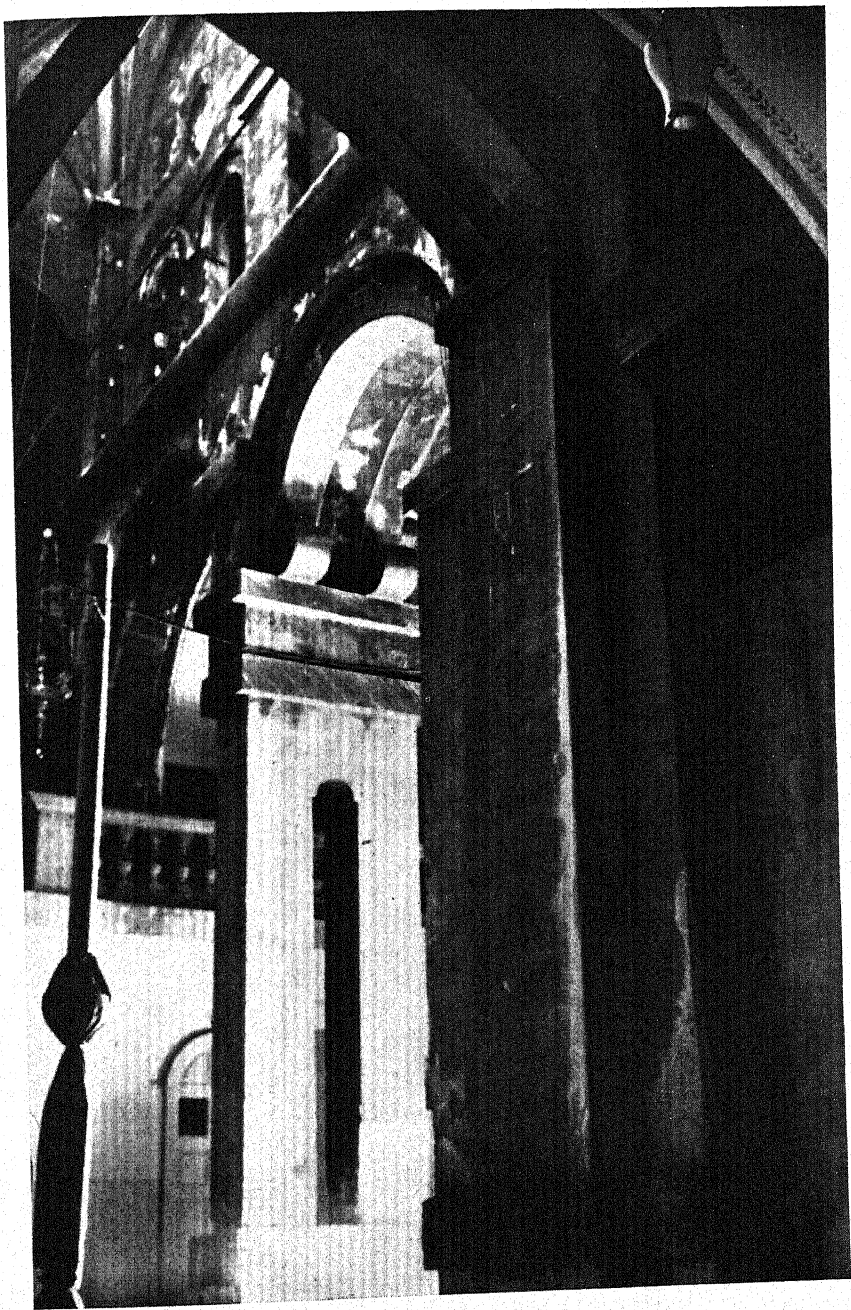
FIG. 21. SOUTH TRANSEPT FROM N.W.

The South Transept (see Figs. I, 1-II, 2), including the main front of the Church, contains much twelfth-century work; but the interior suffered greatly from the fire, and was partly rebuilt (see Figs. 21, 22, 23). The South wall shows very considerable calcining of the masonry, principally in the upper story, and a large proportion of the stonework is unfit to support the superincumbent weight and thrusts.

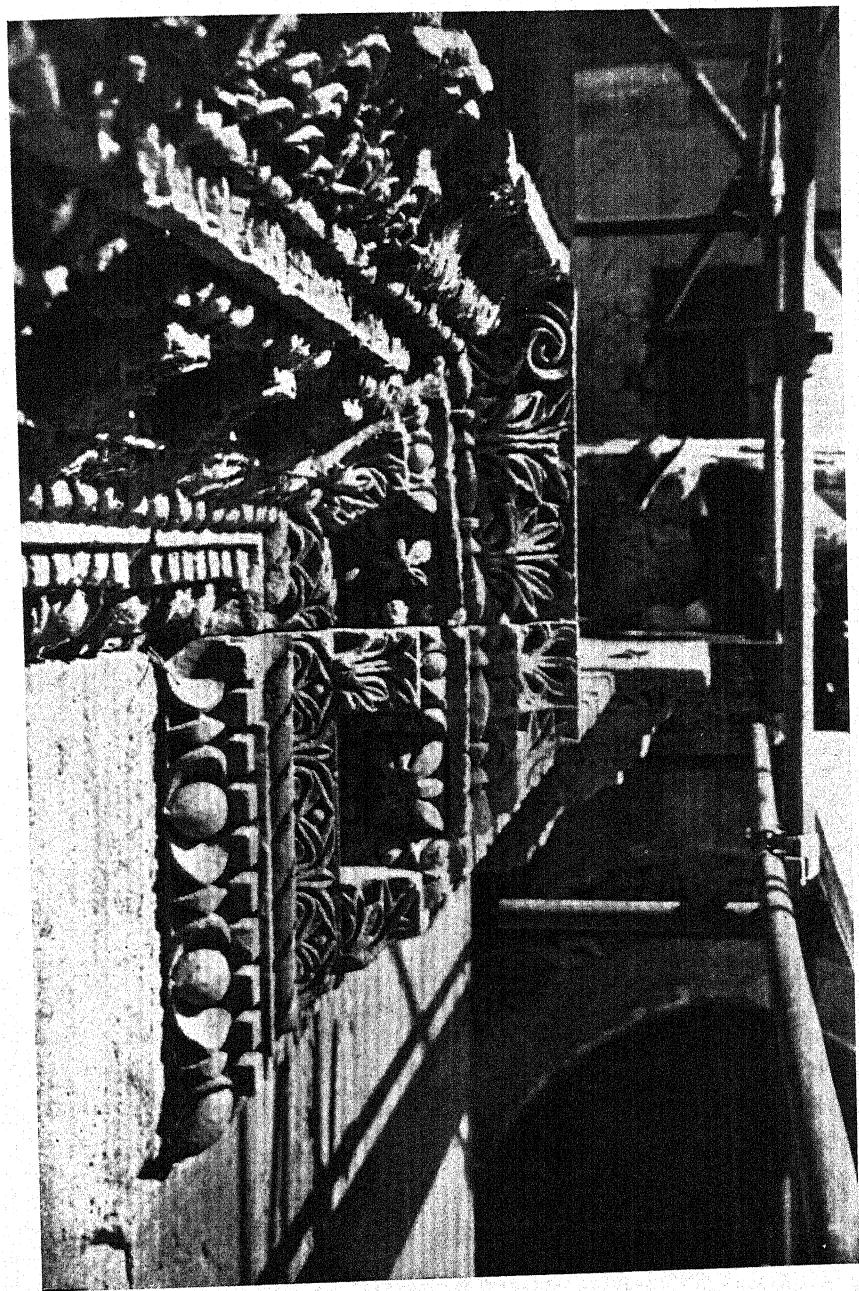
FIG. 25. MAIN FRONT—LOWER CORNICE

The lower colonnettes and their bases are almost all cracked, the oblique direction of the cracks showing the asymmetrical loading of the arches above (see Fig. 24). The condition of most of the carved work is extremely good (see Figs. 25, 26, 27, 28, 29) with the exception of the inner orders of the upper arches, which suffered most from the fire (see Figs. 30, 31, 32).

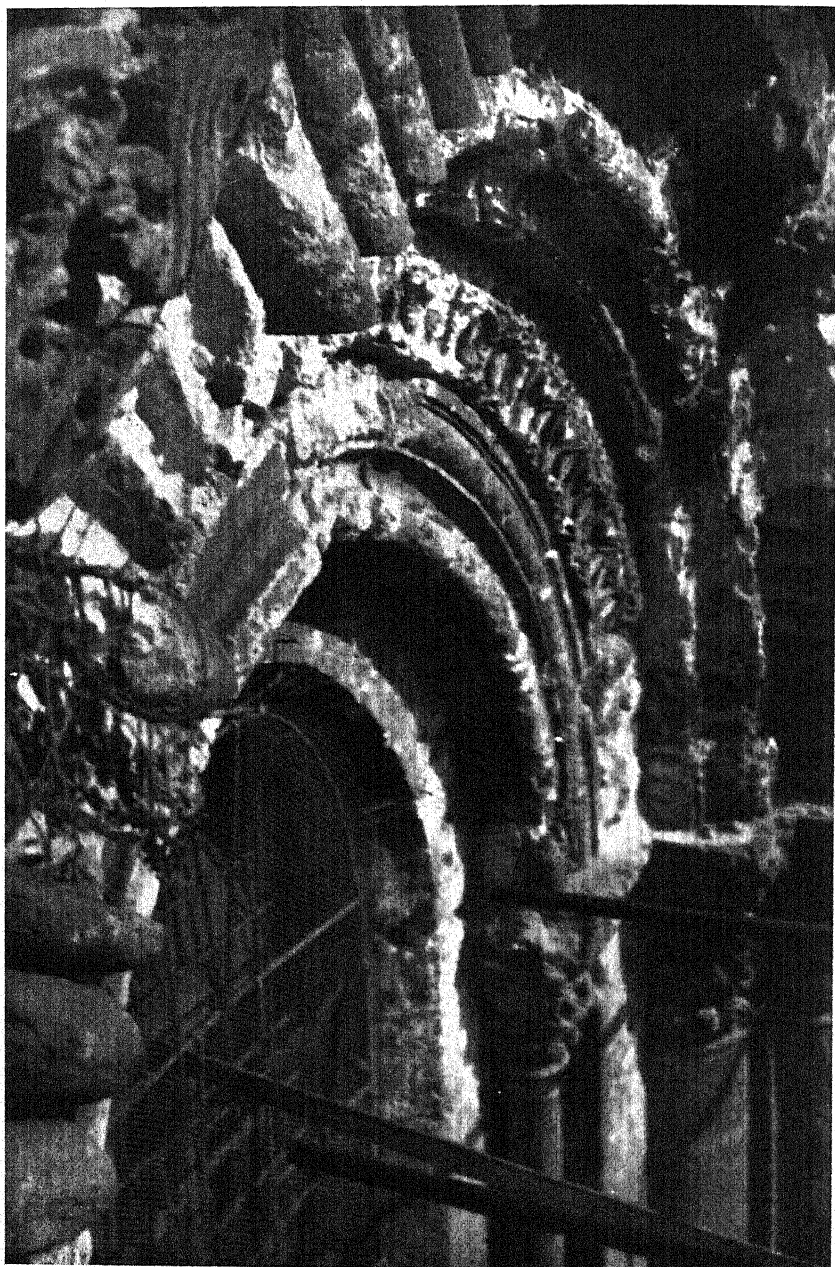
FIG. 30. UPPER ARCHES OF FRONT

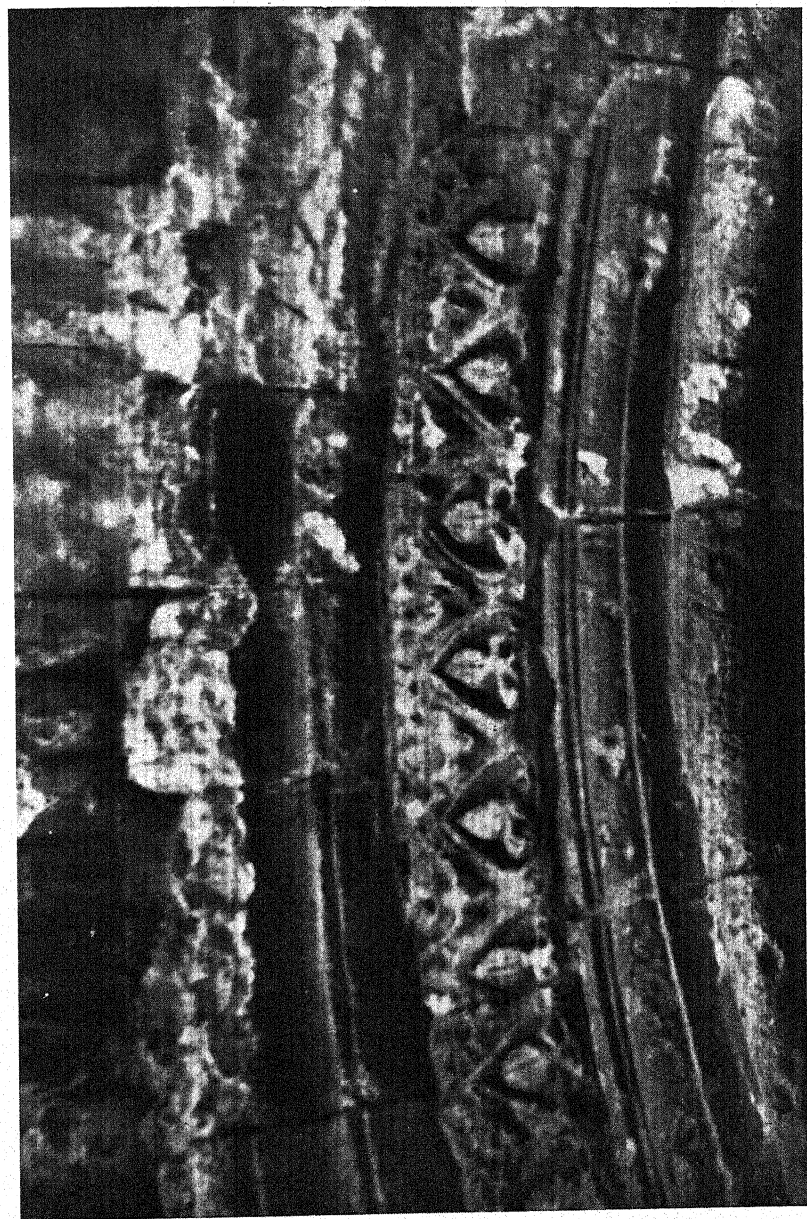
FIG. 31. PART OF CALCINED MOULDINGS TO UPPER ARCHES

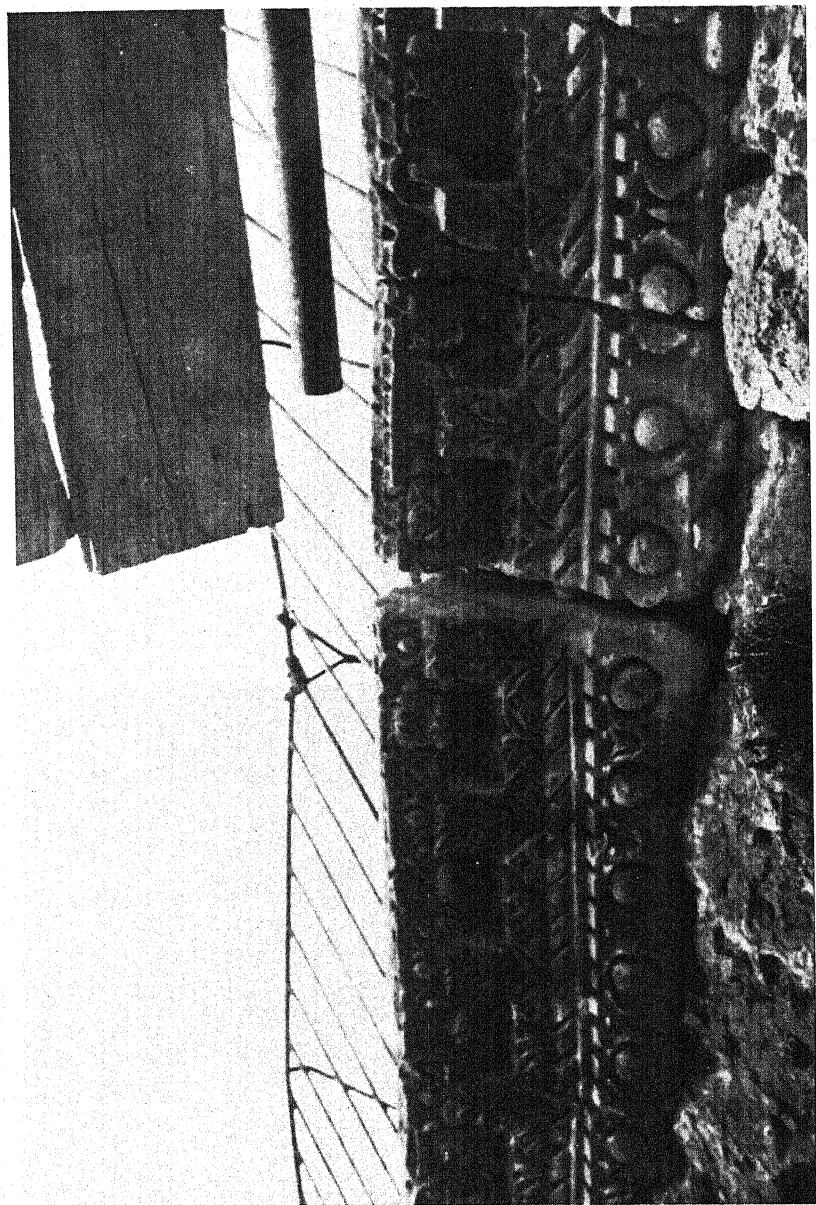
FIG. 33. DISLOCATED BLOCKS OF MAIN CORNICE

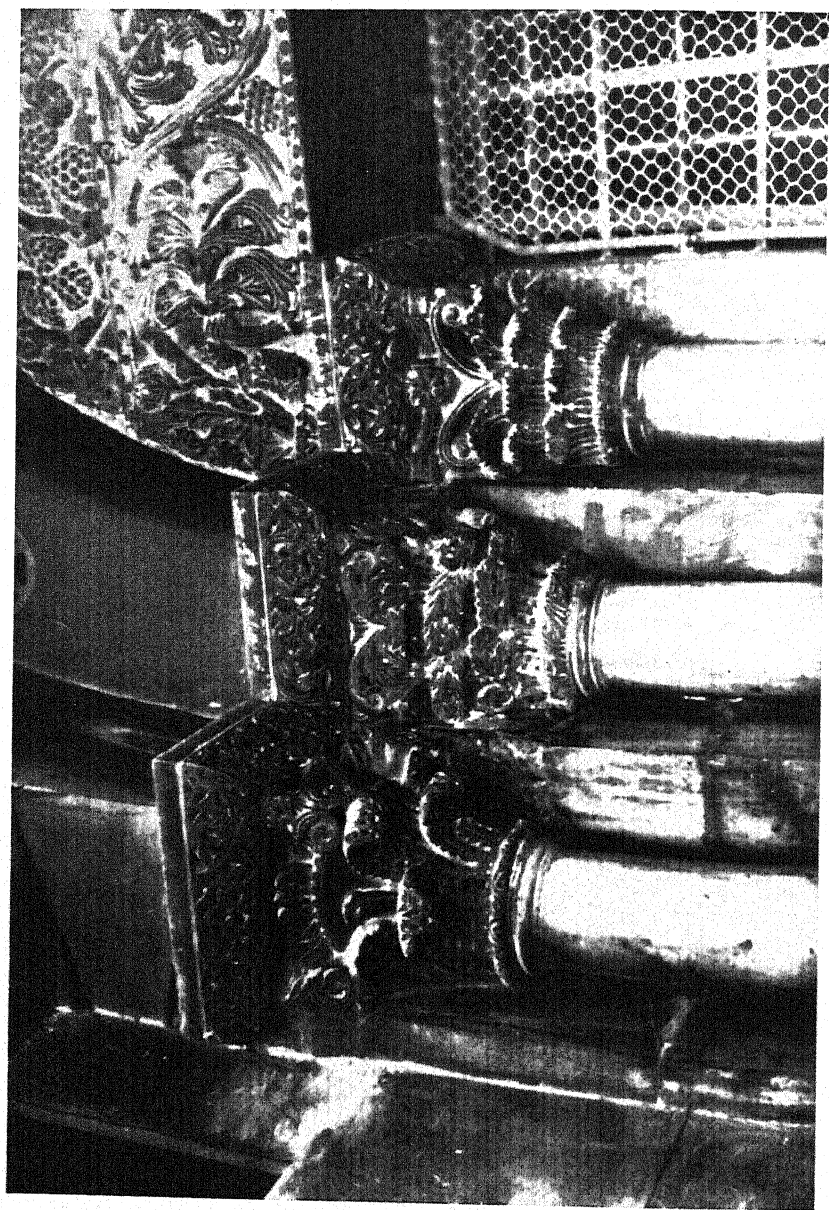
Much carving dating from the twelfth century is found here (see Fig. 51), both on the exterior and inside. While that executed in stone has weathered well on the whole, though damaged by vegetation, some of the work in marble has suffered similar decay to the panels which were removed from above the main doorways.

FIG. 51. CAPITALS OF OLD DOOR TO CALVARY

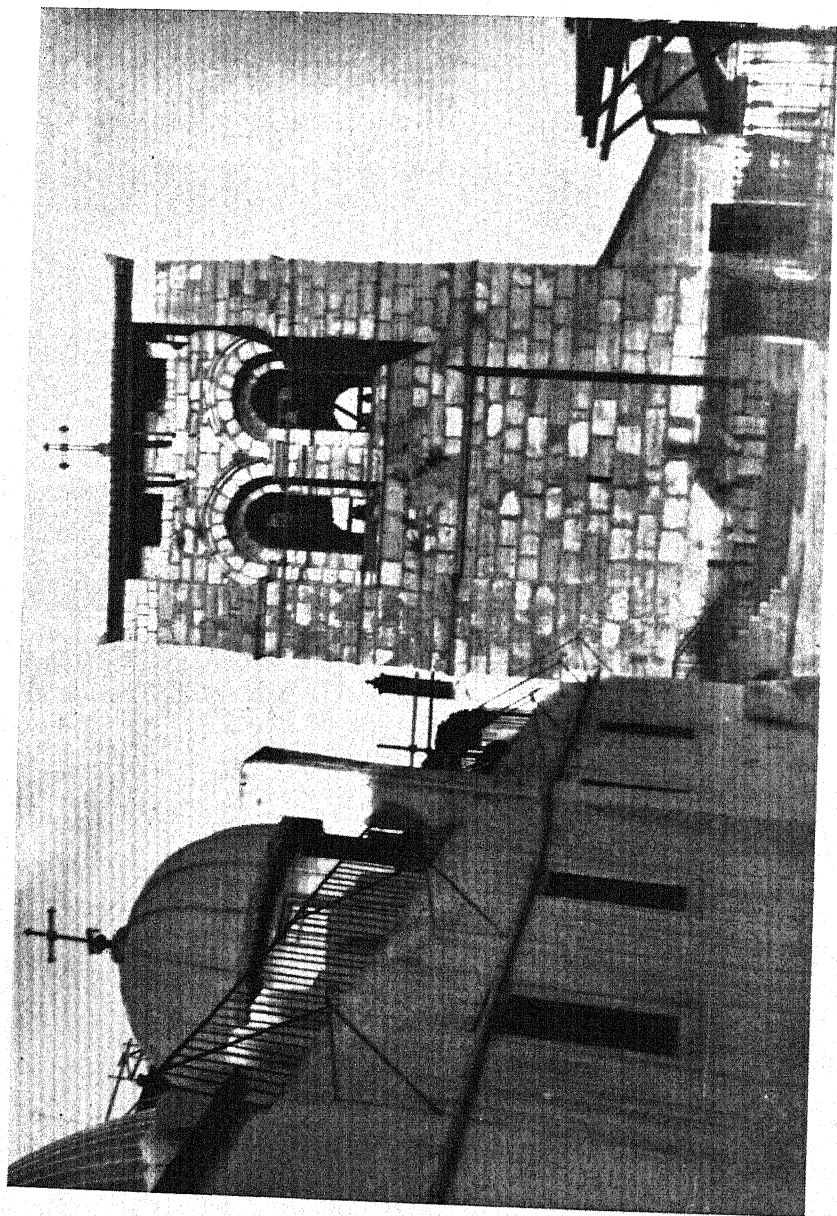
At the top the outward inclination is severe, and has affected the surrounding vaults and further walls (see Fig. 57).

Almost at the top is the small Chapel of St. Constantine (see Fig. II, 21); it is within this that the outer Rotunda wall shows its worst leans, which are also easily perceptible in the opposite South wall of the Chapel, which stands on the Convent roof (see Fig. 57). The condition of both walls at this level is serious, as large cracks in the surface stucco of the Chapel show.

FIG. 57. TOWER FROM W. AND CHAPEL OF CONSTANTINE

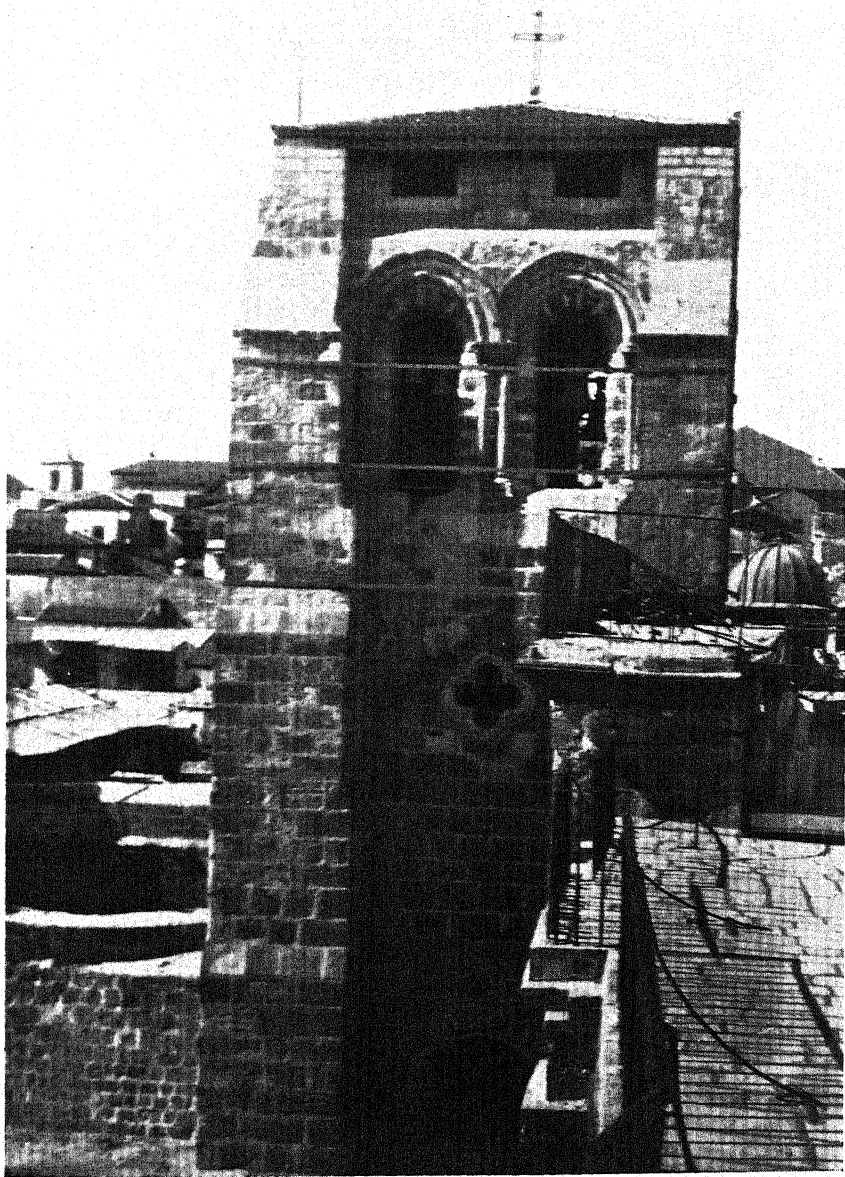
Previously the roof had collapsed to the south in the earthquake of 1545, and carried with it the dome of the old Baptistery (see Fig. 58).

FIG. 58. TOWER FROM E.

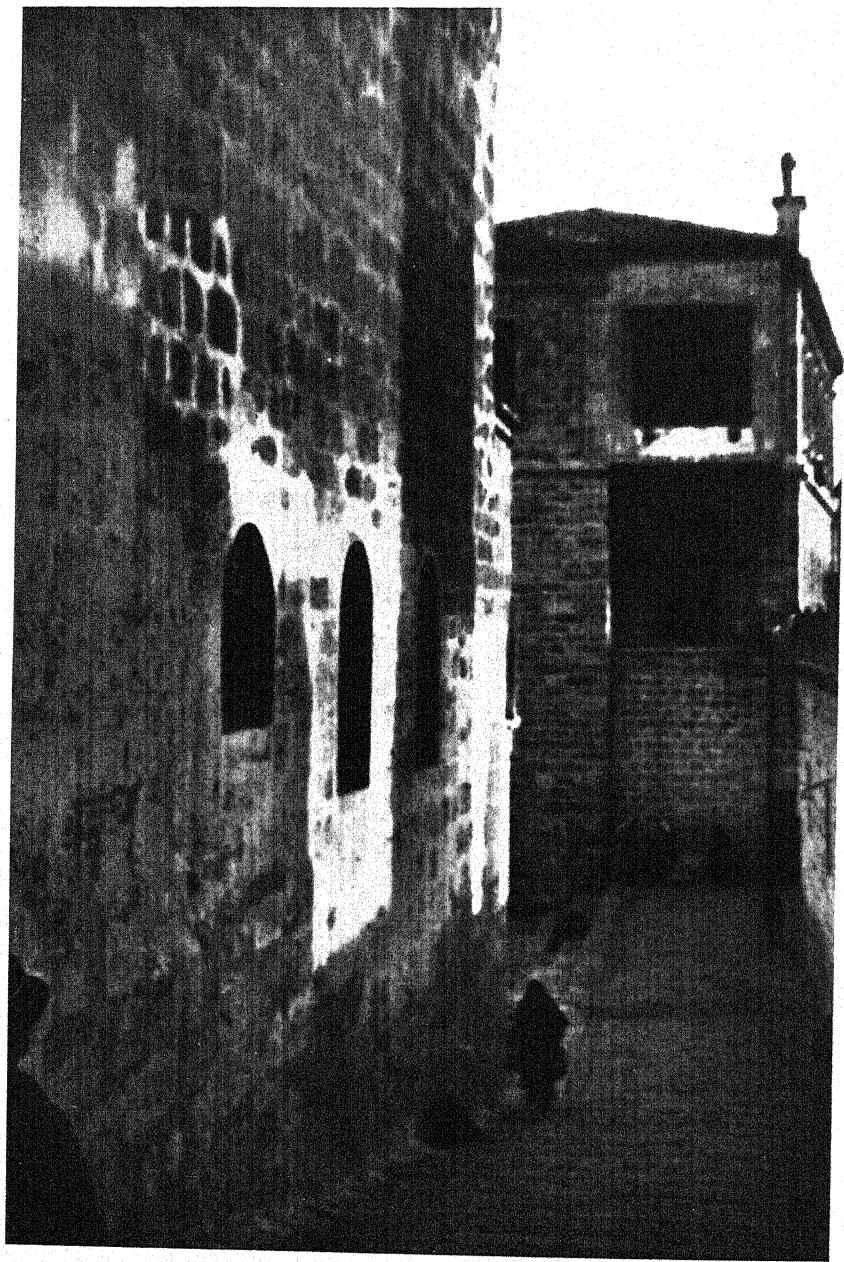
This Chapel is in a state of grave danger, as the lower half of its South wall (see Figs. 61, 62) overhangs the adjoining street

FIG. 61. SOUTH WALL OF CHAPEL OF ST. JAMES

A lower series of reinforcements must also be placed in the walls of the old Baptistery and the Chapel of St. James, which leans dangerously towards the street. This band should be carried through into the vaults between the Rotunda and South Transept, and anchored to the main piers.

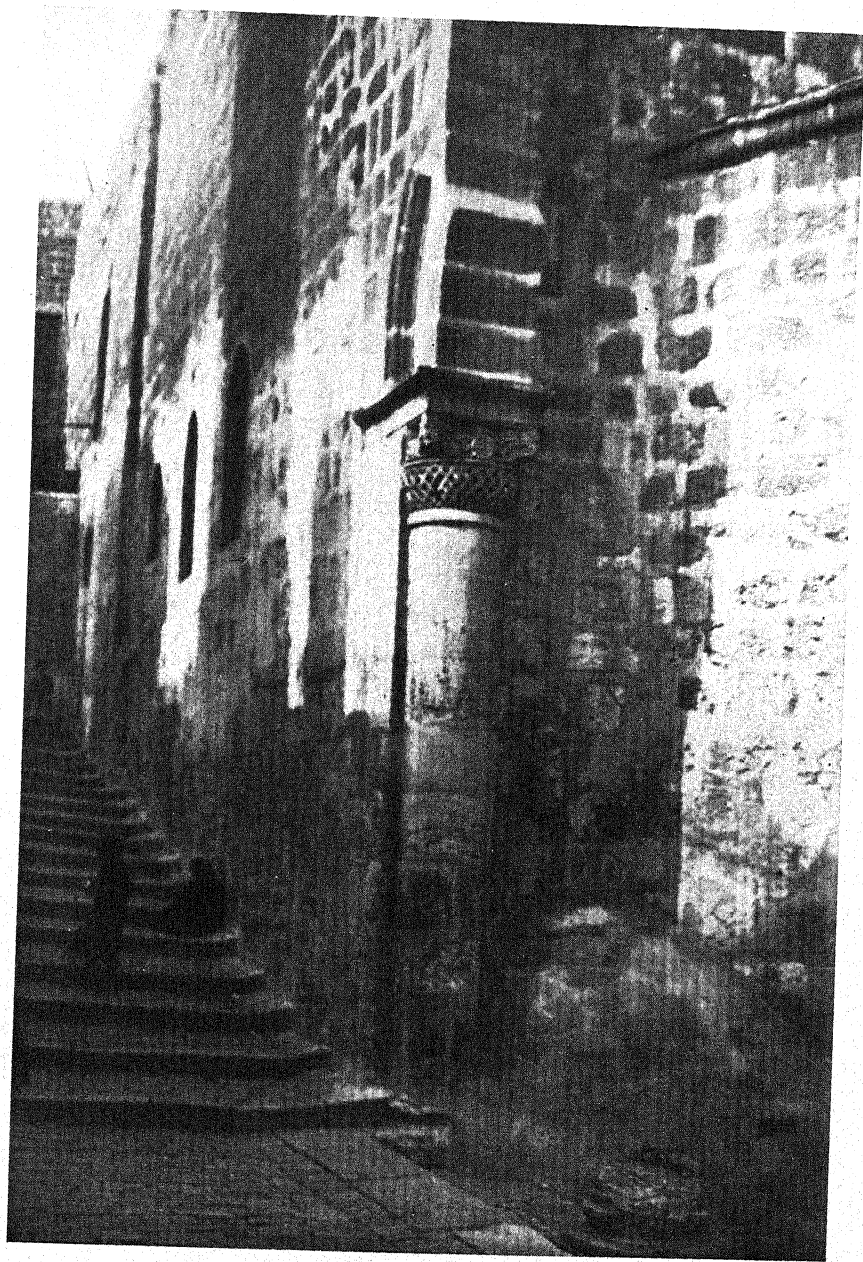
FIG. 62. SOUTH WALL OF CHAPEL OF ST. JAMES

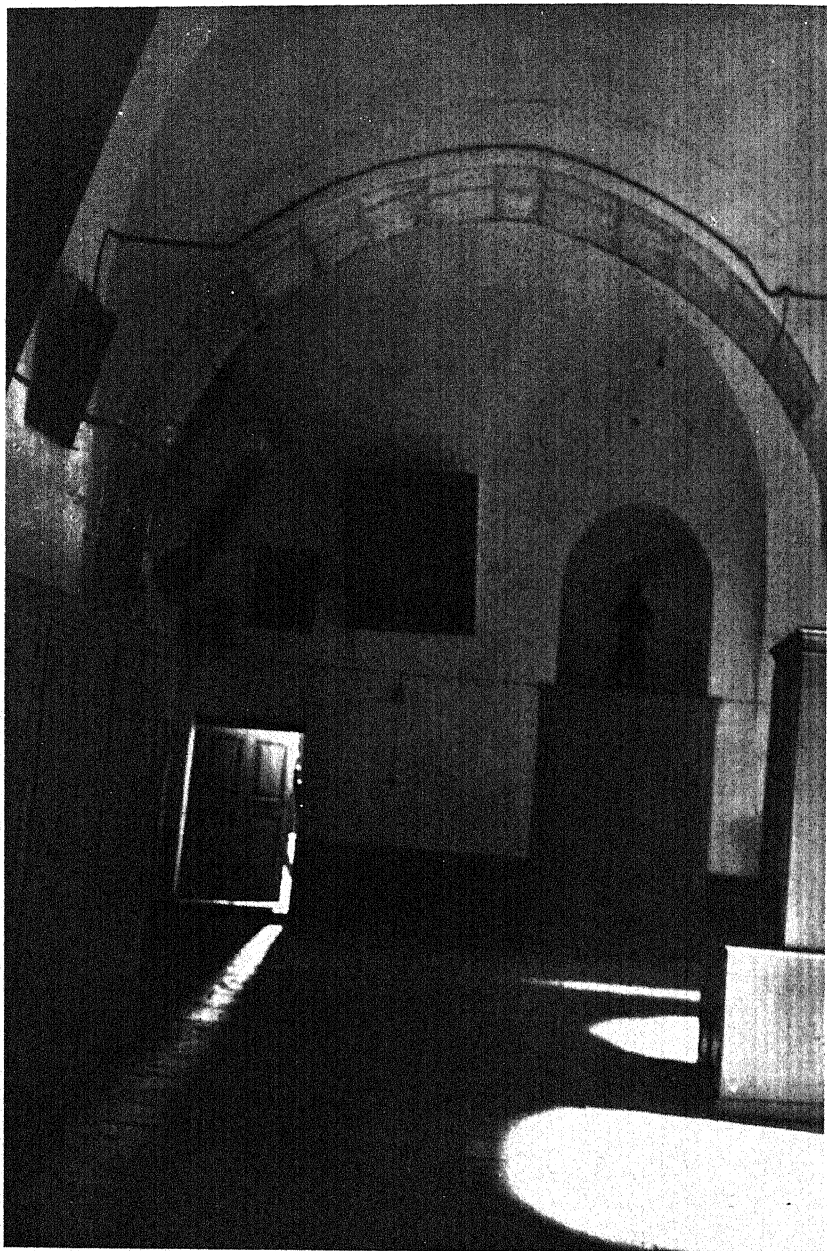
The galleries of the Rotunda (see Fig. 67) surround the main piers, and are enclosed by a circular wall, whose lower portions date from Constantine's original Anastasis (see Fig. 68). This circular wall leans outwards owing to the thrusts of the gallery vaults and the communicated thrusts of the cone which covered the central space prior to 1808.

FIG. 67. FRANCISCAN UPPER GALLERY OF ROTUNDA

A series of tie-bars across the arches of the upper Rotunda gallery, connected to a band of reinforcement in the outer wall may also be required to stabilize this wall and the inner colonnade.

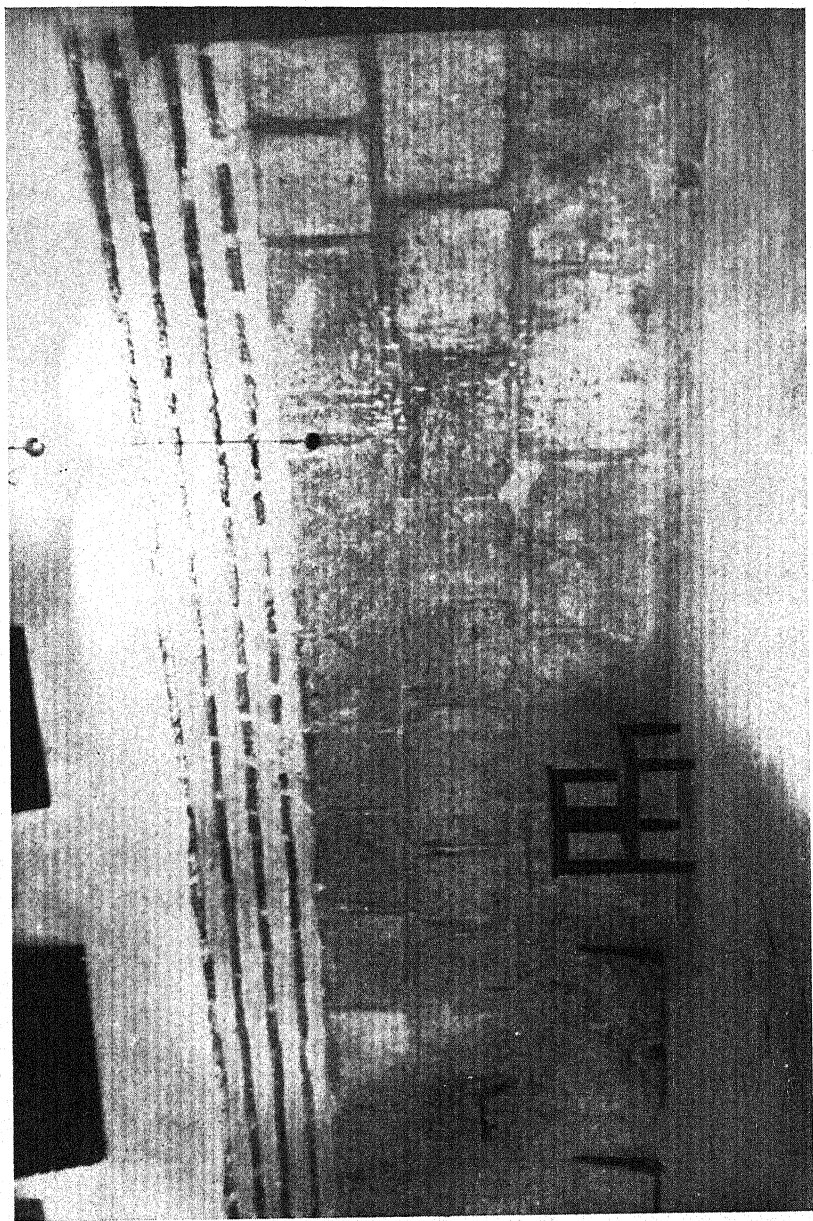
FIG. 68. BYZANTINE OUTER WALL OF ROTUNDA IN UPPER GALLERY

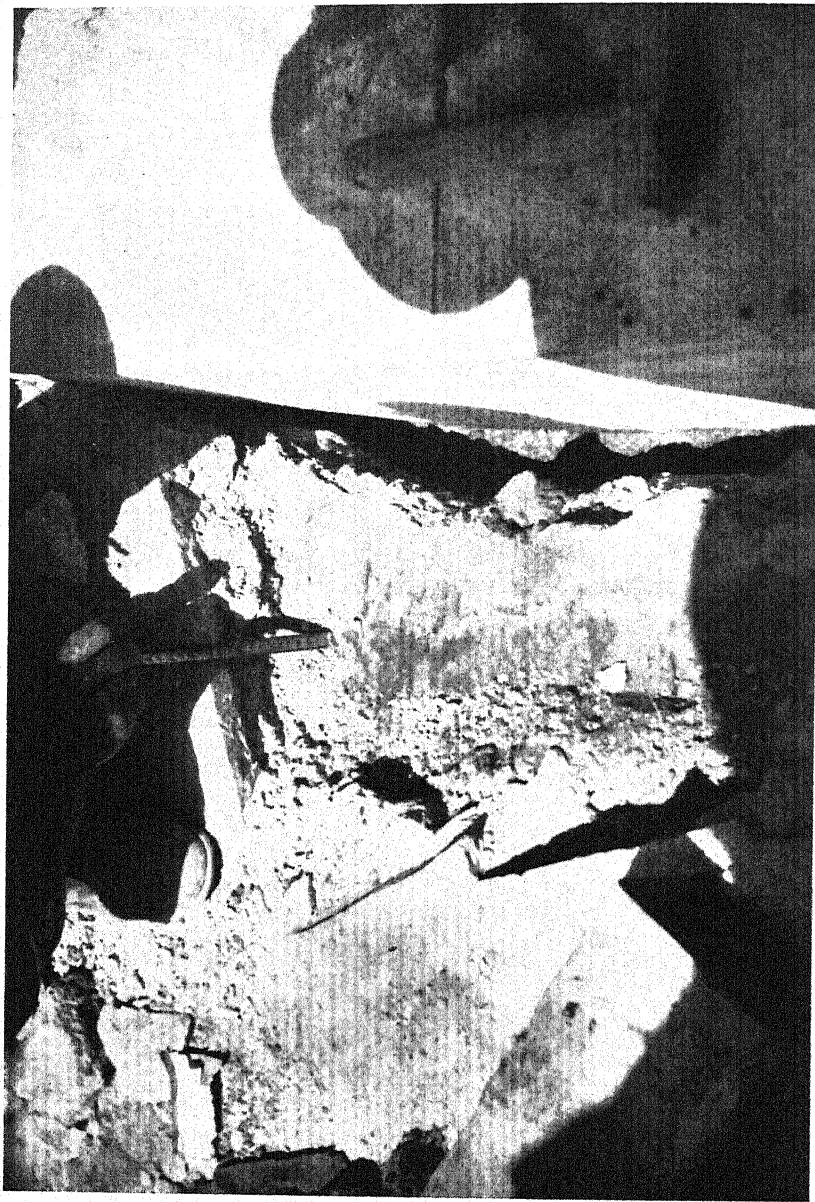
The roofs in general are in a bad state, and allow much rain-water to penetrate to the interior. As previously mentioned this has led to much extra weight being imposed on the building as successive layers of roofing material have been laid (see Fig. 69).

FIG. 69. PORTION OF HIGH VAULT ROOF, SHOWING SUPERIMPOSED
LEVELS OF SLABS

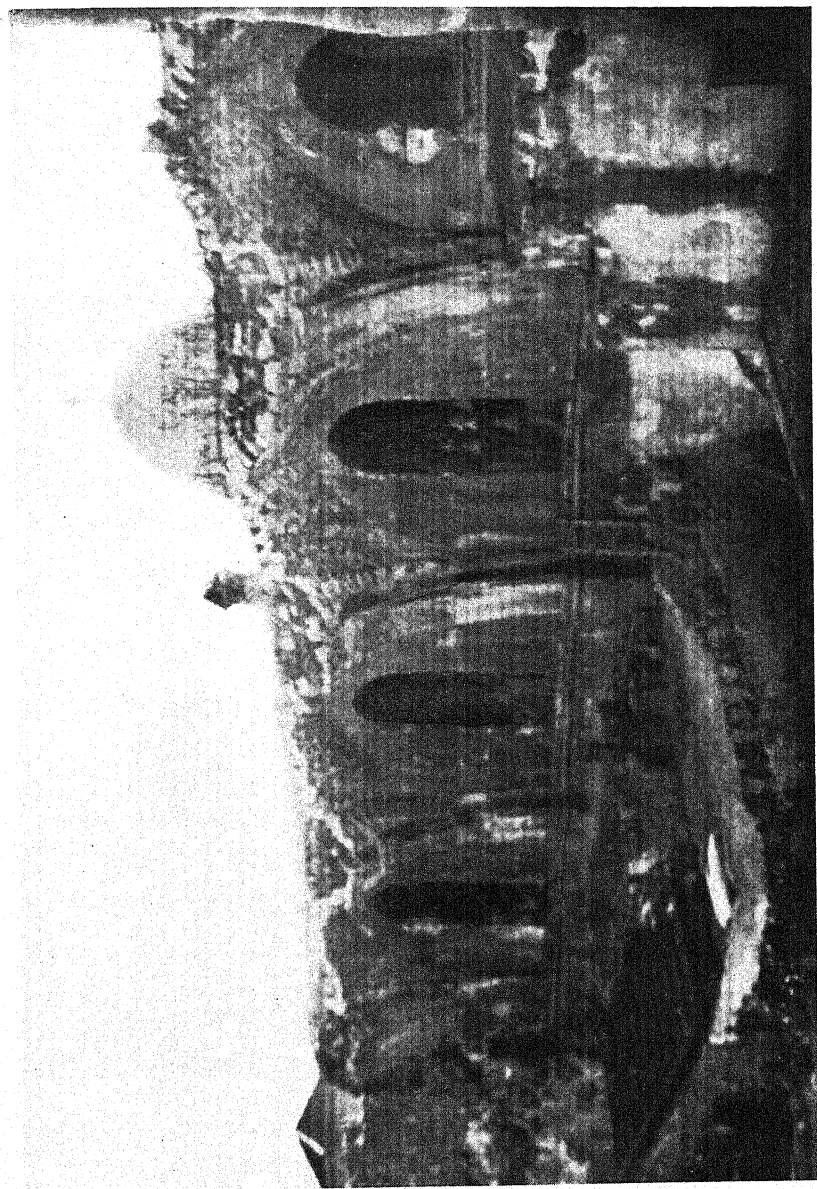
Secondly, the major part of the South wall of the old Latin Refectory (see Figs. 70, 71, II, 14) is in a ruined state, with large masses of overhanging vaulting. These are cracking away from the wall, and there is grave danger of their collapse.

FIG. 70. RUINED SOUTH WALL OF OLD REFECTORY
